CCC 145 POST LRT CONSTRUCTION/PRE-HIGH-RISE BLAST CRACK SURVEY

OTTAWA, ONTARIO October 17, 2019

19366

CCC 145 - POST LRT CONSTRUCTION / PRE-HIGH-RISE BLAST - CRACK SURVEY

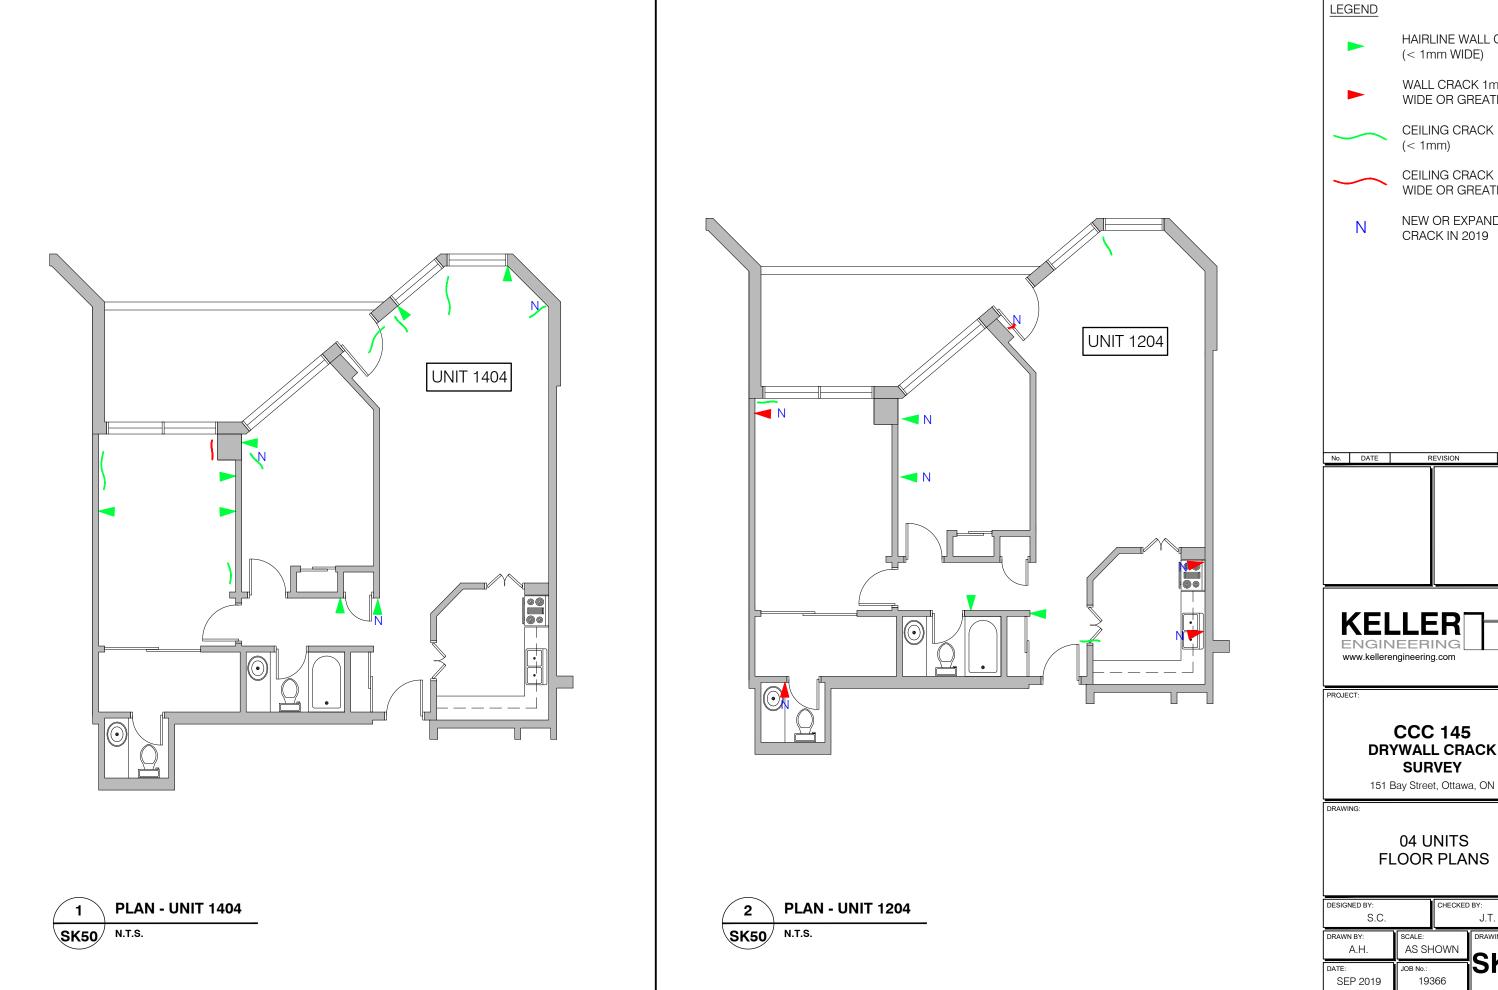
SK50

04 UNITS FLOOR PLANS
