CCC 145 – POST CLARIDGE EXCAVATION – CRACK SURVEY

At your request, Keller Engineering performed a follow-up crack survey of all unit interiors and the garage of Carleton Condominium Corporation No. 145 (CCC No. 145) located at 151 Bay Street in Ottawa, ON. The crack survey of all units of CCC 145 was conducted between July 27, 2020 and July 29, 2020 as the blasting for the new high-rise tower in the parking lot on Slater and Lyon, adjacent to CCC No. 145 was completed.

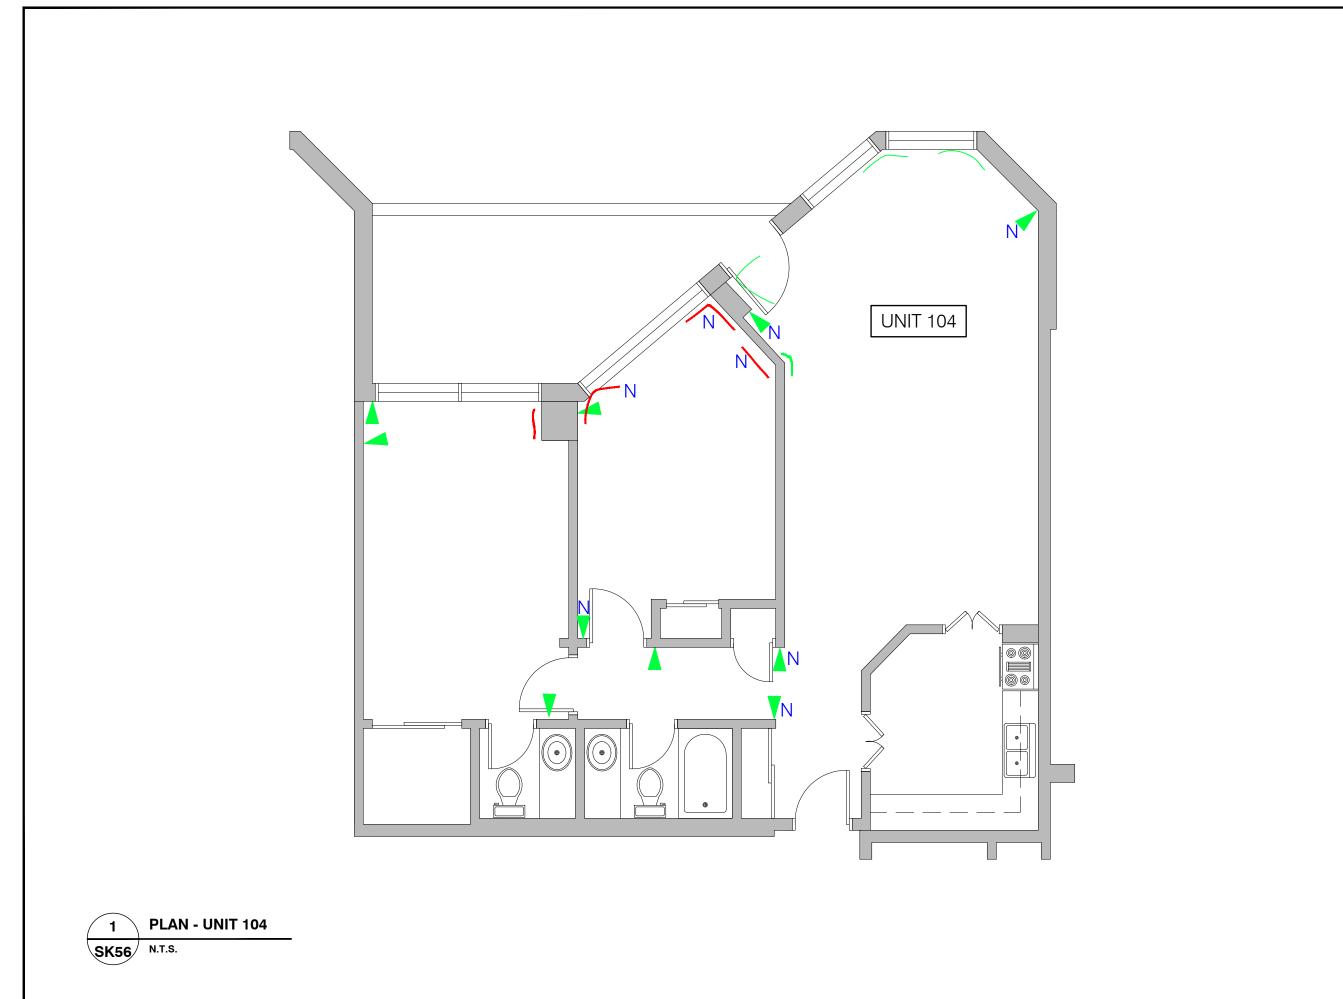
LEGEND HAIRLINE WALL CRACK (< 1mm WIDE) WALL CRACK 1mm WIDE OR GREATER CEILING CRACK (< 1mm) CEILING CRACK 1mm WIDE OR GREATER NEW OR EXPANDED CRACK IN 2020 No. DATE REVISION DRAWN www.kellerengineering.com **CCC 145 DRYWALL CRACK** SURVEY 151 Bay Street, Ottawa, ON 04 UNITS FLOOR PLANS CHECKED BY: DESIGNED BY: S.C. J.T. SCALE: AS SHOWN DRAWN BY: **SK56**

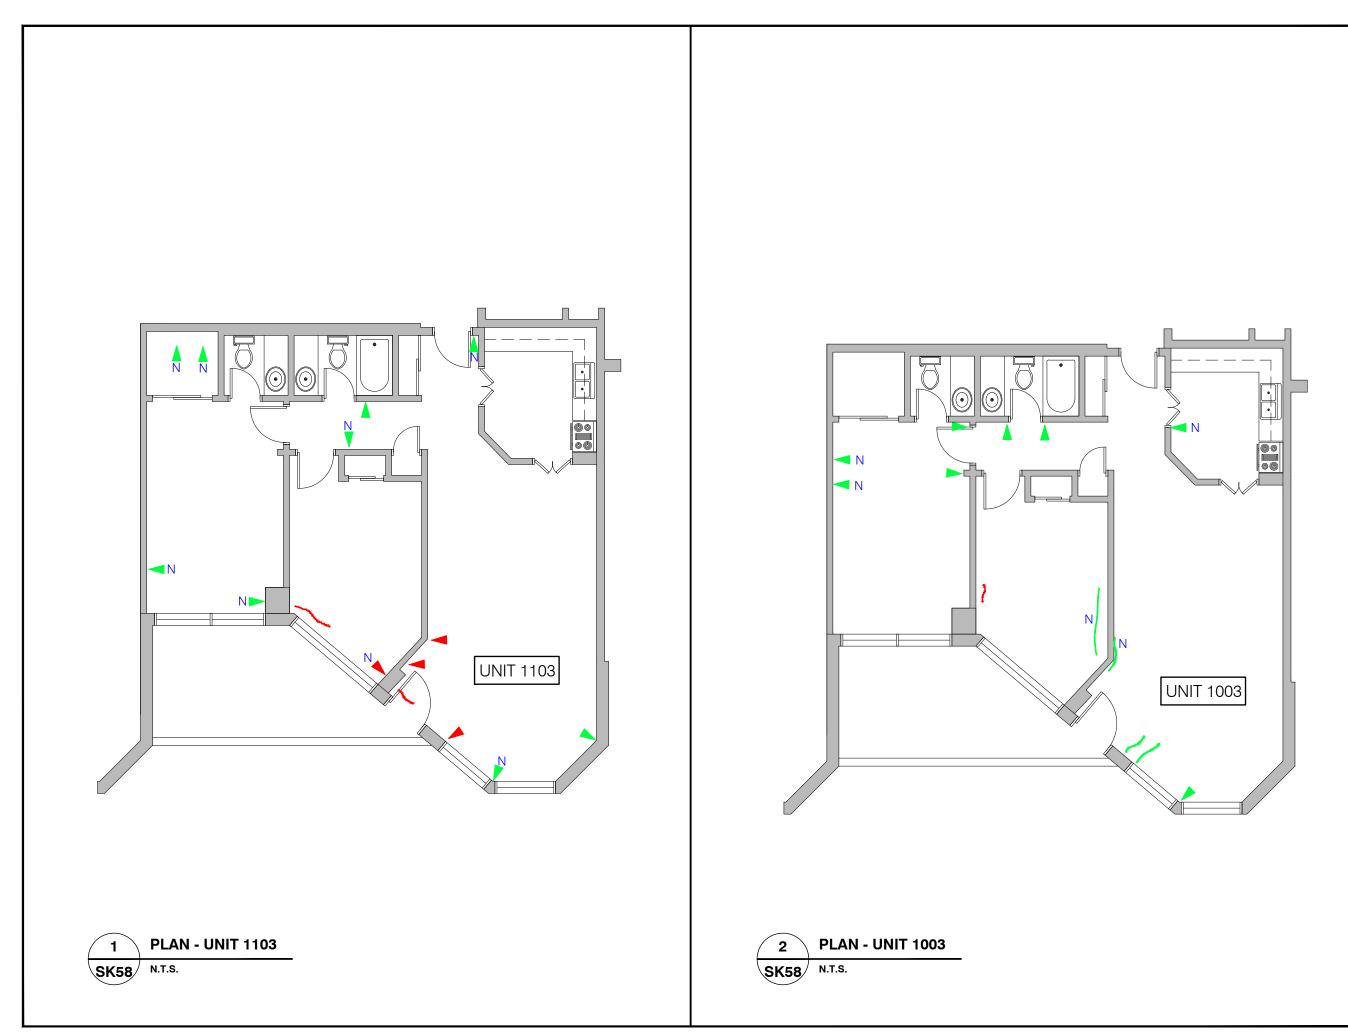
<u>LEGEND</u> HAIRLINE WALL CRACK (< 1mm WIDE) WALL CRACK 1mm WIDE OR GREATER CEILING CRACK (< 1mm) CEILING CRACK 1mm WIDE OR GREATER NEW OR EXPANDED CRACK IN 2020 No. DATE REVISION DRAWN www.kellerengineering.com PROJECT: **CCC 145 DRYWALL CRACK SURVEY** 151 Bay Street, Ottawa, ON 03 UNITS FLOOR PLANS DESIGNED BY: CHECKED BY: S.C. J.T. AS SHOWN **SK58**

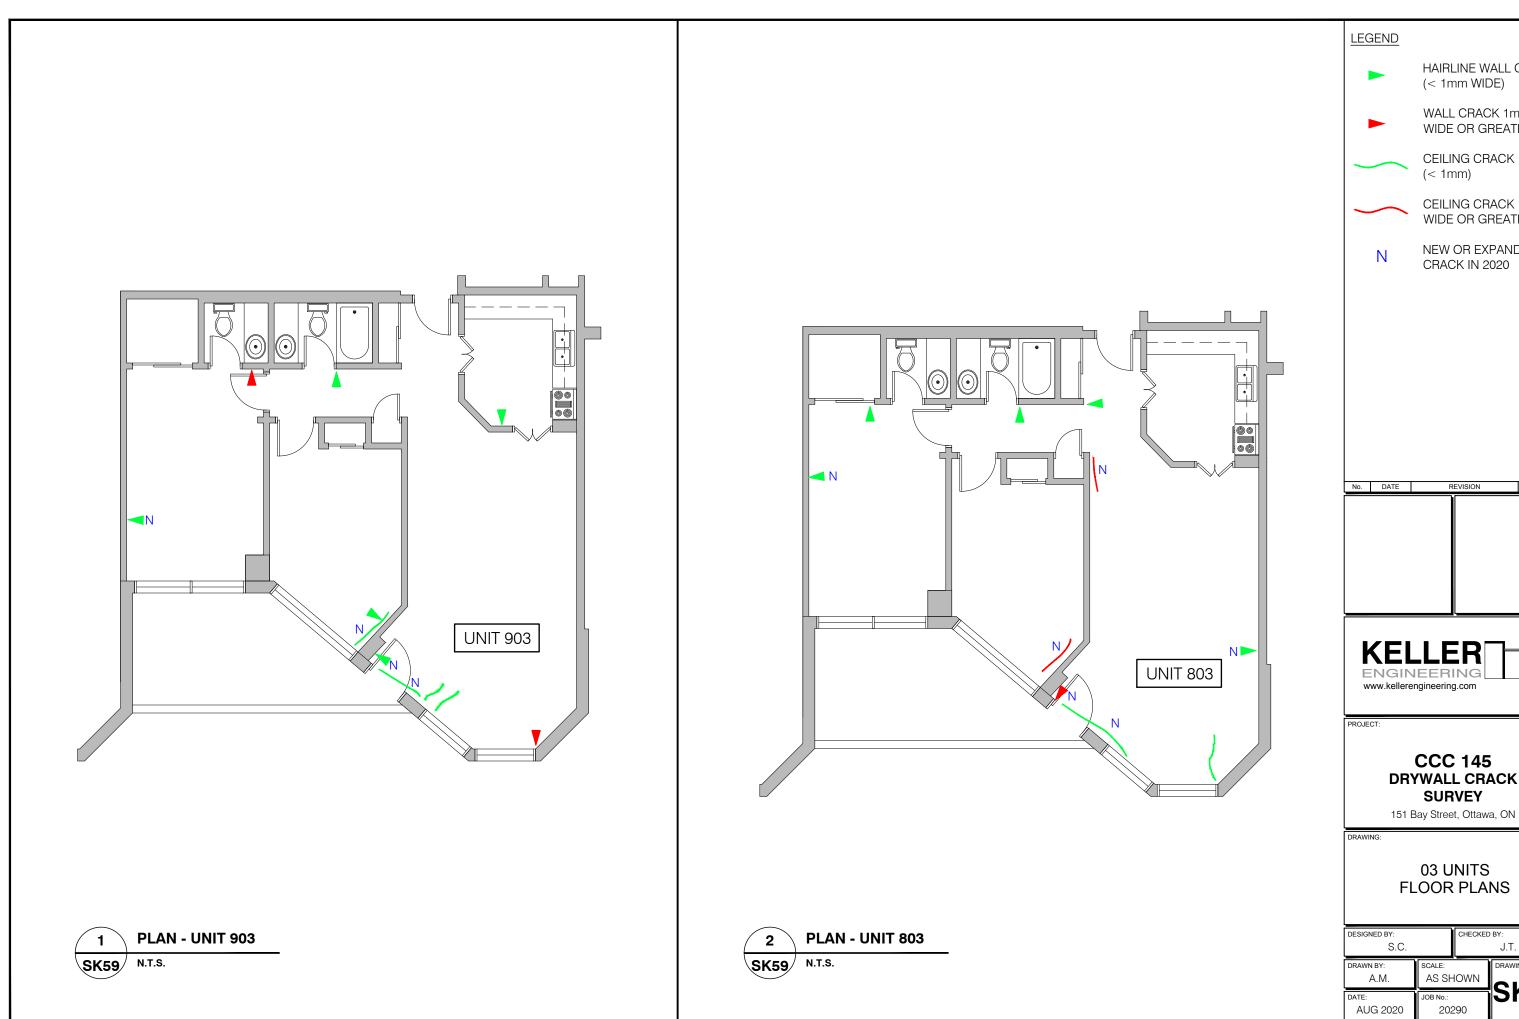
HAIRLINE WALL CRACK WALL CRACK 1mm WIDE OR GREATER CEILING CRACK CEILING CRACK 1mm WIDE OR GREATER **NEW OR EXPANDED** DRAWN **DRYWALL CRACK** 151 Bay Street, Ottawa, ON

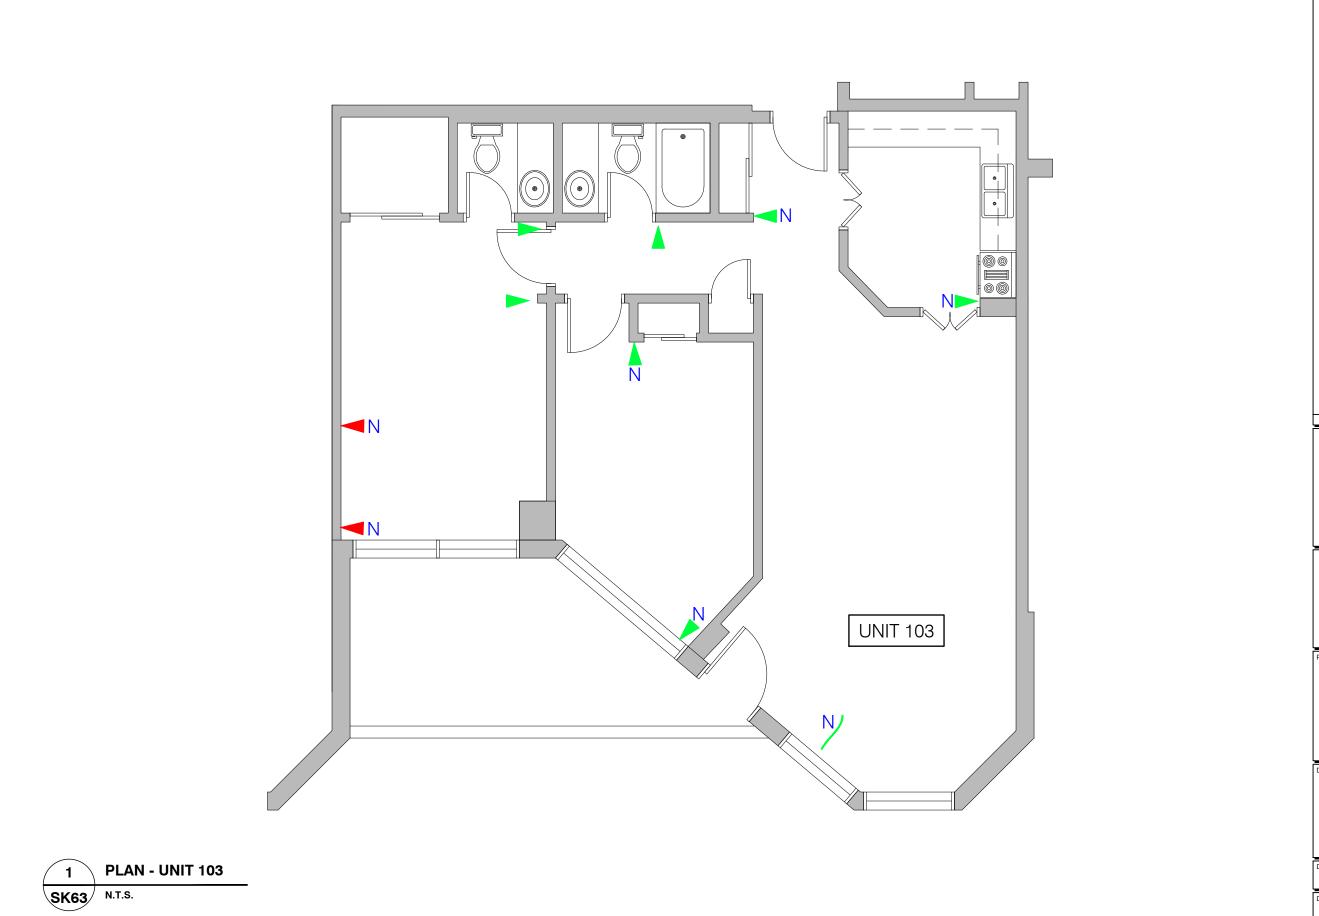
LEGEND HAIRLINE WALL CRACK (< 1mm WIDE) WALL CRACK 1mm WIDE OR GREATER CEILING CRACK (< 1mm) CEILING CRACK 1mm WIDE OR GREATER NEW OR EXPANDED CRACK IN 2020 No. DATE REVISION DRAWN www.kellerengineering.com PROJECT: **CCC 145 DRYWALL CRACK** SURVEY 151 Bay Street, Ottawa, ON 03 UNITS FLOOR PLANS DESIGNED BY: CHECKED BY: J.T. S.C. AS SHOWN **SK63** 20290 AUG 2020
